# The Right to Roam: A Strategy to Reconnect a Continental Wildlife Pathway in the Frontenac Arch

June 19, 2023

This report was prepared by the following authors on behalf of the Algonquin to Adirondacks Collaborative (A2A):

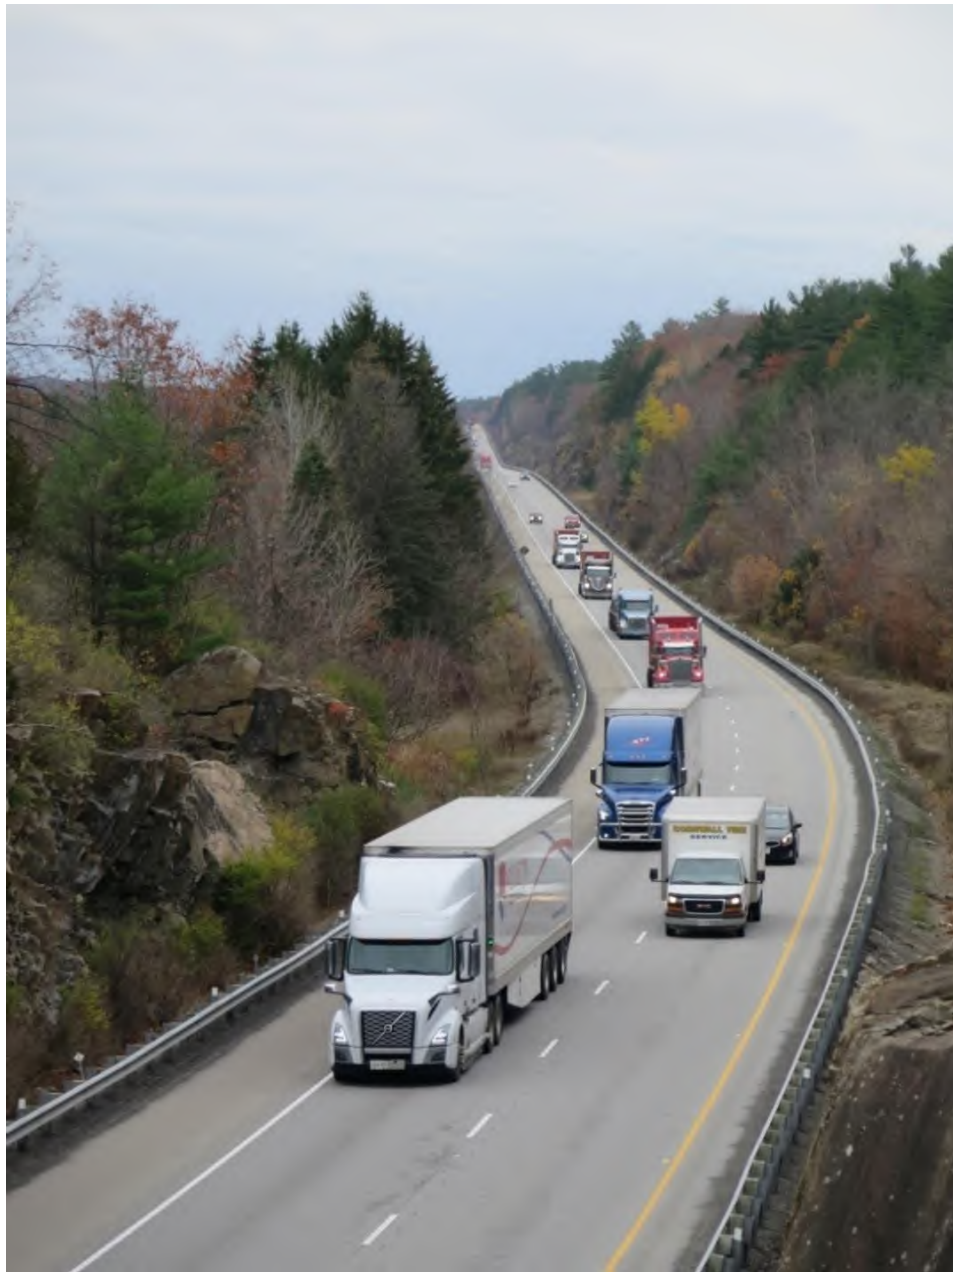
Proposed location for a wildlife overpass on Highway 401 near Escott-Rockport Road, Mallorytown  
(taken by R. Danby)

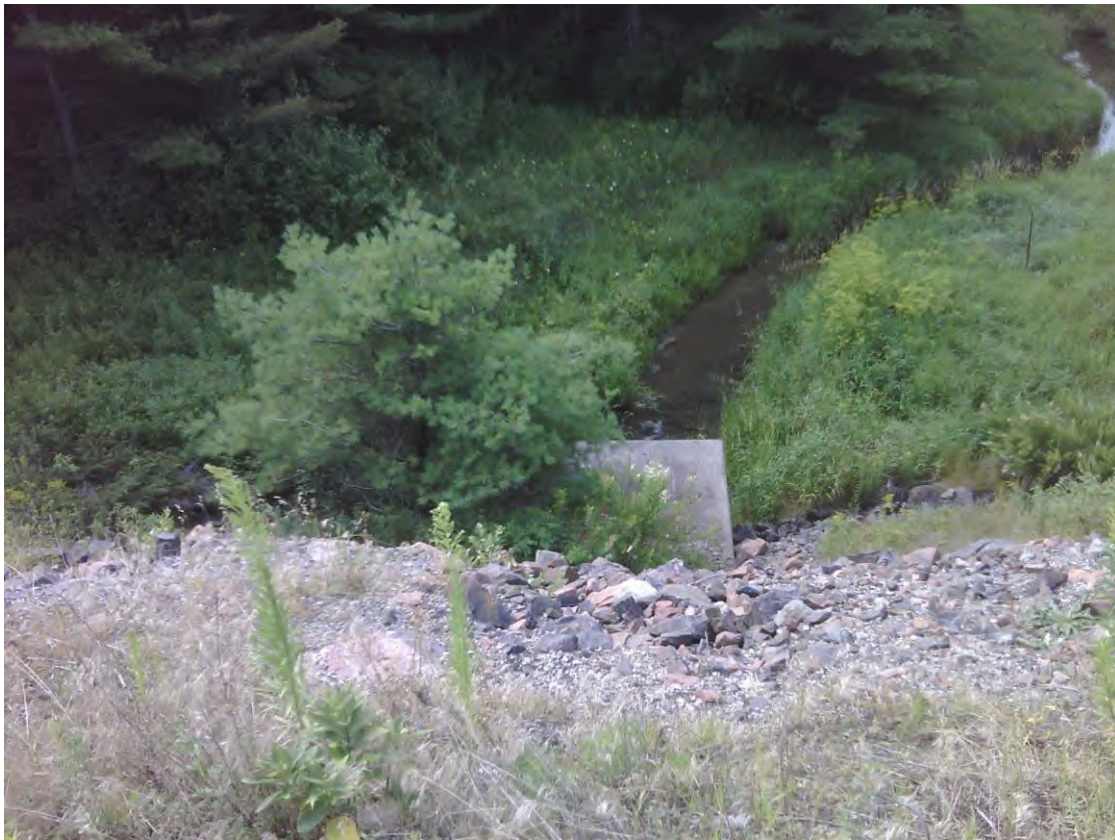
A box culvert currently exists at Landons Bay Creek where it crosses Highway 401 and may be suitable for the passage of small and medium-sized mammals, but with potential for significant improvements (Figure 14). This culvert (MTO ID 002204010006) is 2.4 m tall, 2.4 m wide, and 73.8 m long, with an openness ratio (height x width divided by length) of 0.078. An openness ratio of 0.05 is the minimum required for small and medium-sized mammals that are adapted to nocturnal and/or tunnel-like conditions, while larger openness ratios are needed for common herpetiles and at-risk herpetiles (0.1 and 0.25, respectively; Gartner Lee and EcoPlans, 2009). A smaller culvert along this stretch of Highway 401 (MTO ID 002204010030) has low suitability for the passage of herpetiles due to its small size. This culvert is 0.6 m tall, 0.6 m wide, and 28.4 m long, with an openness ratio of 0.013. This culvert also lacks continuity at the highway median and this separation increases travel distance and traffic noise (Ross, 2004). The corresponding area was identified as a location of moderate road mortality for vertebrates along Highway 401 (Danby et al., 2016).

Figure 14: Photo of the existing box culvert at the Landons Bay Creek-Highway 401 crossing.

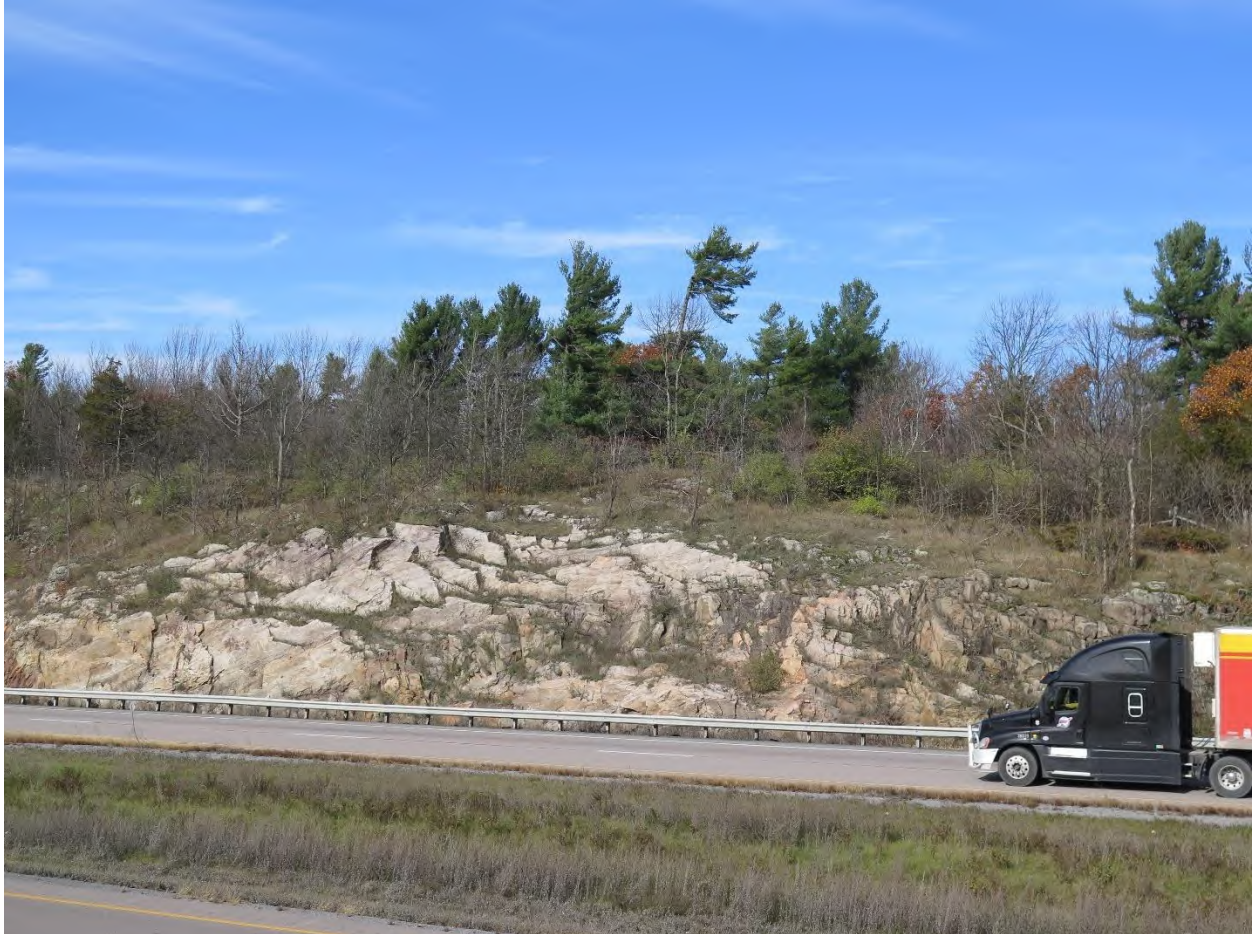
Figure 15: Photo of rock cuts along Highway 401 at the proposed overpass location within the Landons Bay to Lansdowne pathway.

An overpass should be installed over Highway 401 to connect Landons Bay on the south side of the highway to the wetland complex on the north side (Figure 13). Rock cuts of approximately the same elevation on both sides of the lower-lying roadbed would facilitate the construction of an overpass here (Figure 15). Overpasses function as large landscape bridges over highways to enable the passage of a diversity of wildlife, including large mammals, birds, bats, and herpetiles, and are more likely to be used if they incorporate habitat characteristics (Clevenger & Huijser, 2011). They also provide a route for wildlife species that may be deterred from underpasses due to their relatively damp and dark conditions (Danby et al., 2016).

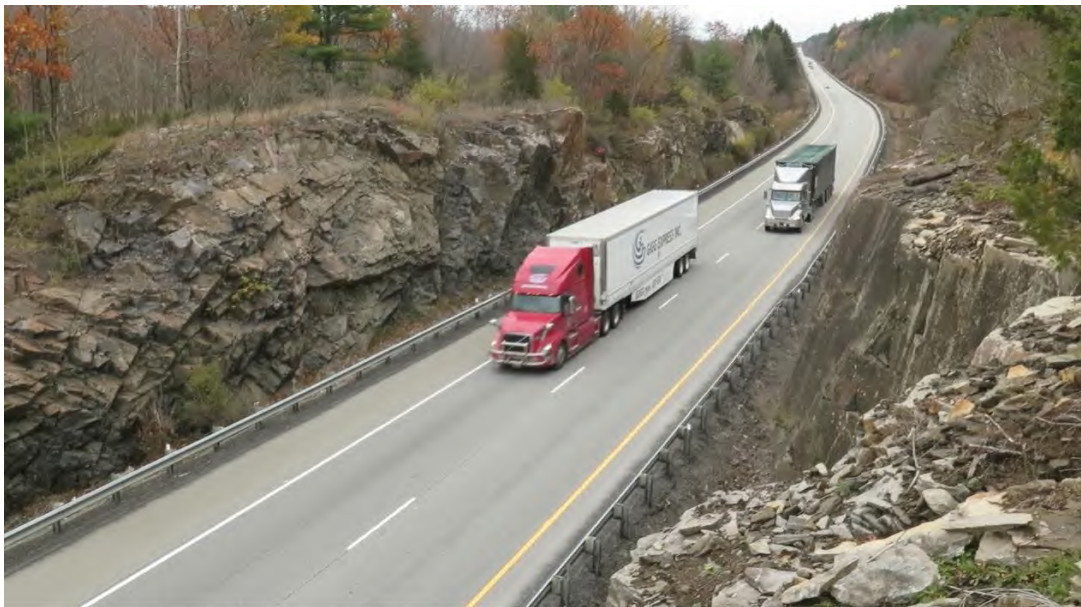
Figure 18: Photo of rock cuts along Highway 401 at the proposed western overpass location within the Rockport to Waterton pathway.

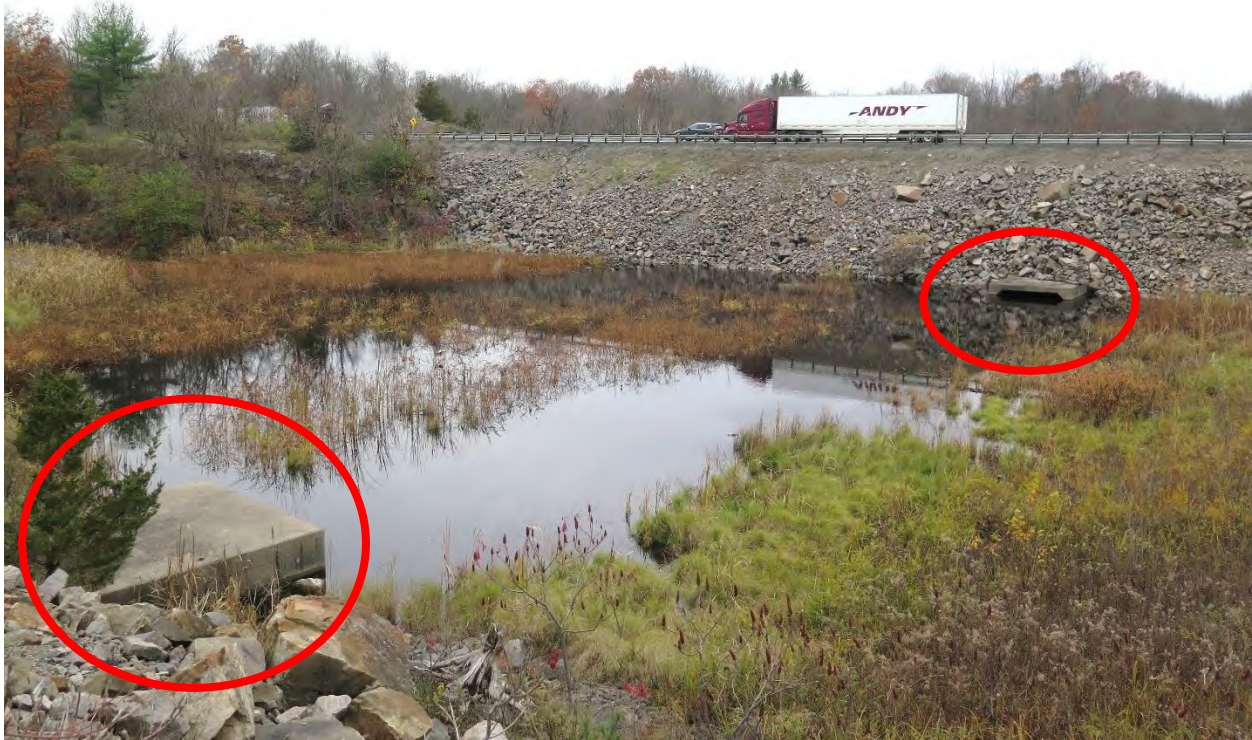
Figure 19: Photo of flooded box culverts (circled in red) on Highway 401 between Highway 137 and Escott-Rockport Road.

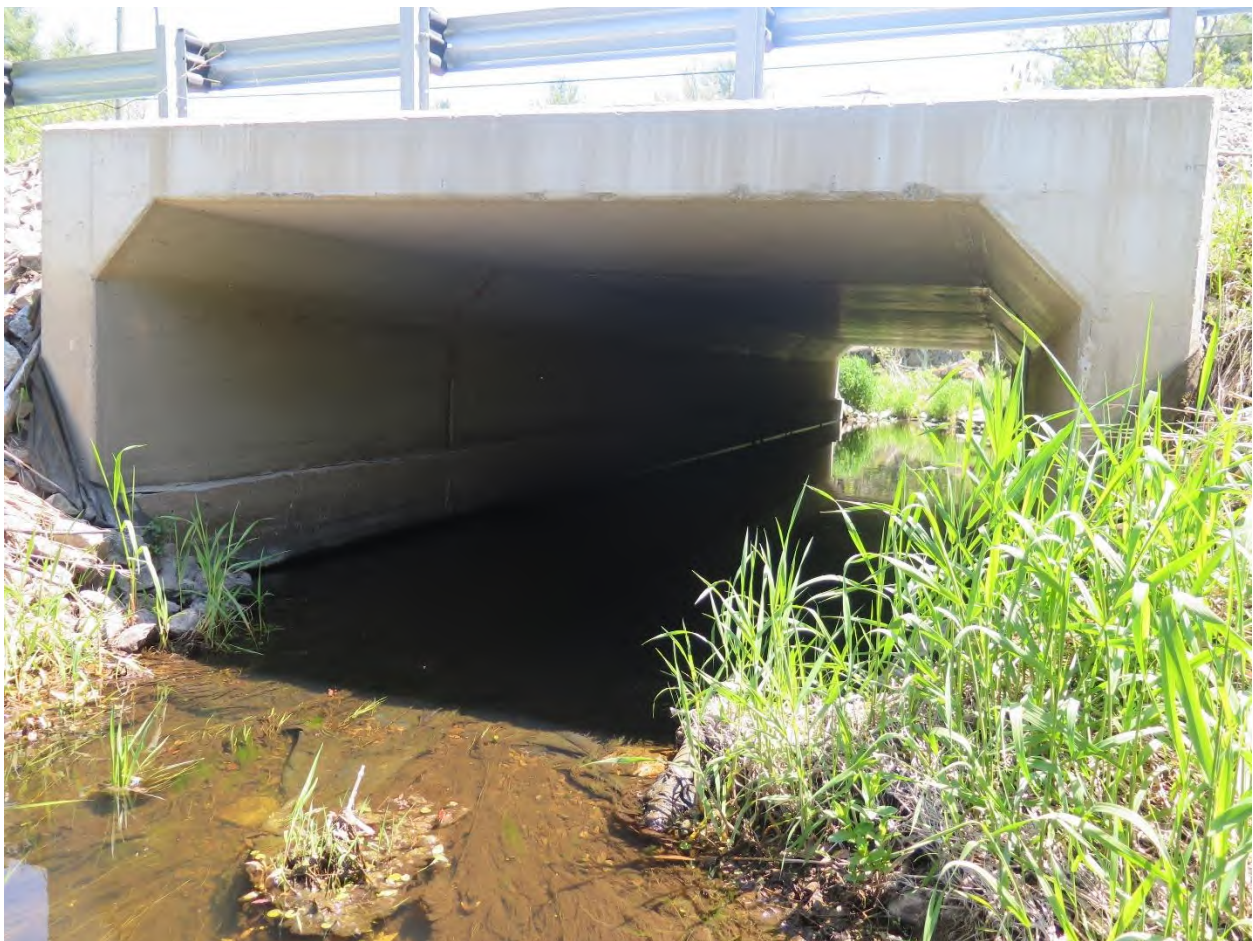
Figure 20: Photo of box culvert on County Road 2 within the Rockport to Waterton pathway.

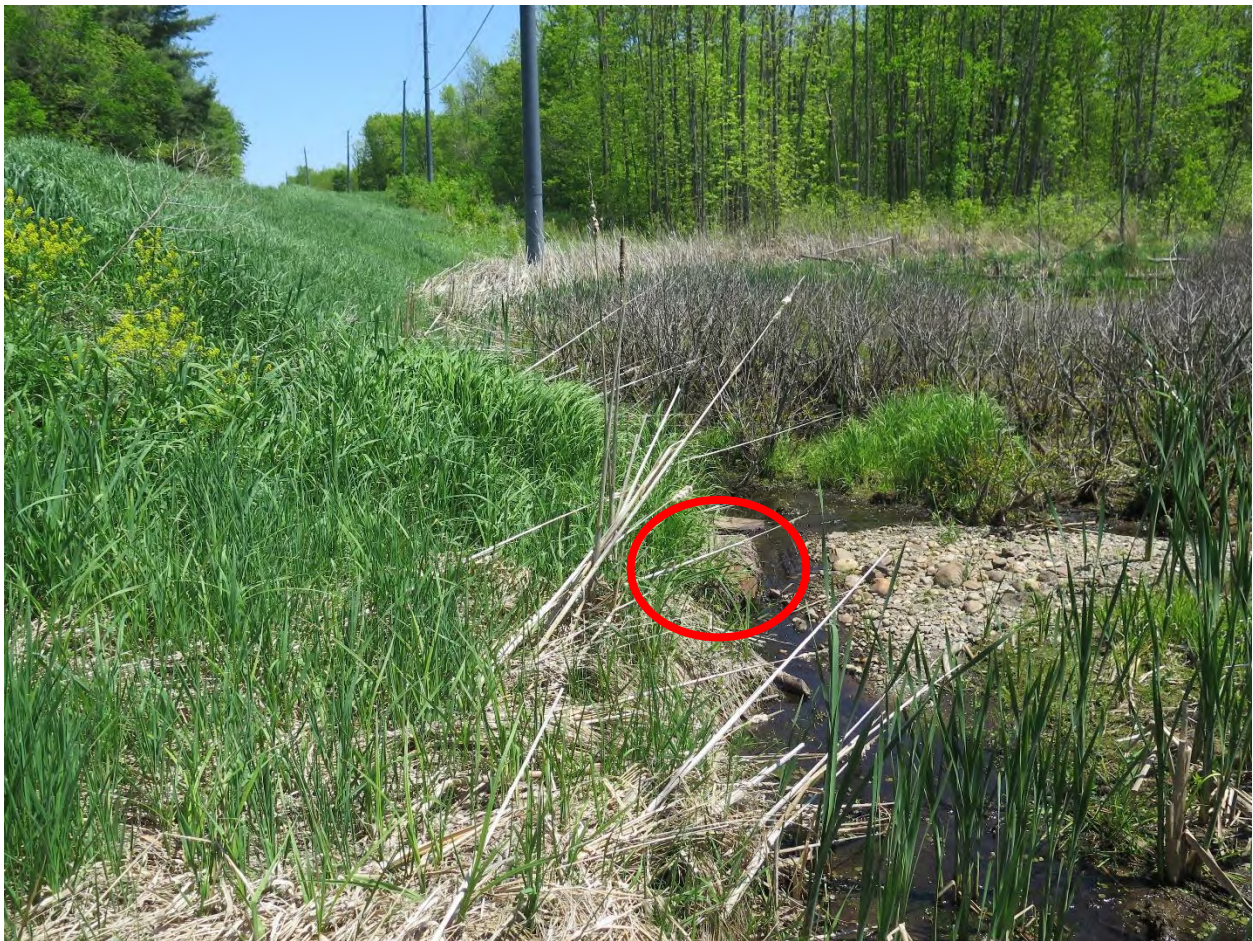
Figure 21: Photo of the undersized culvert on County Road 2 within the Rockport to Waterton pathway.

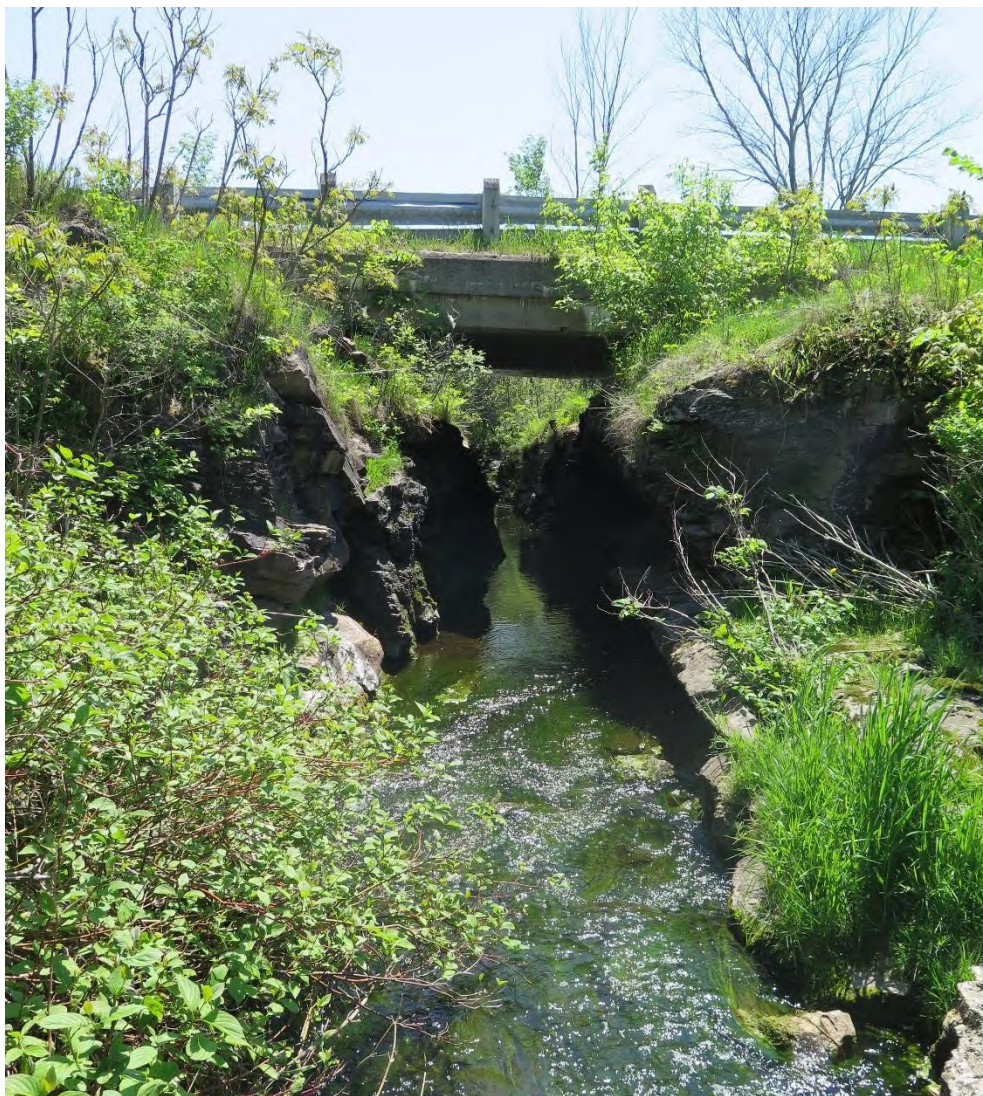
Figure 22: Photo of the bridge on County Road 2 that crosses a tributary of LaRue Creek.

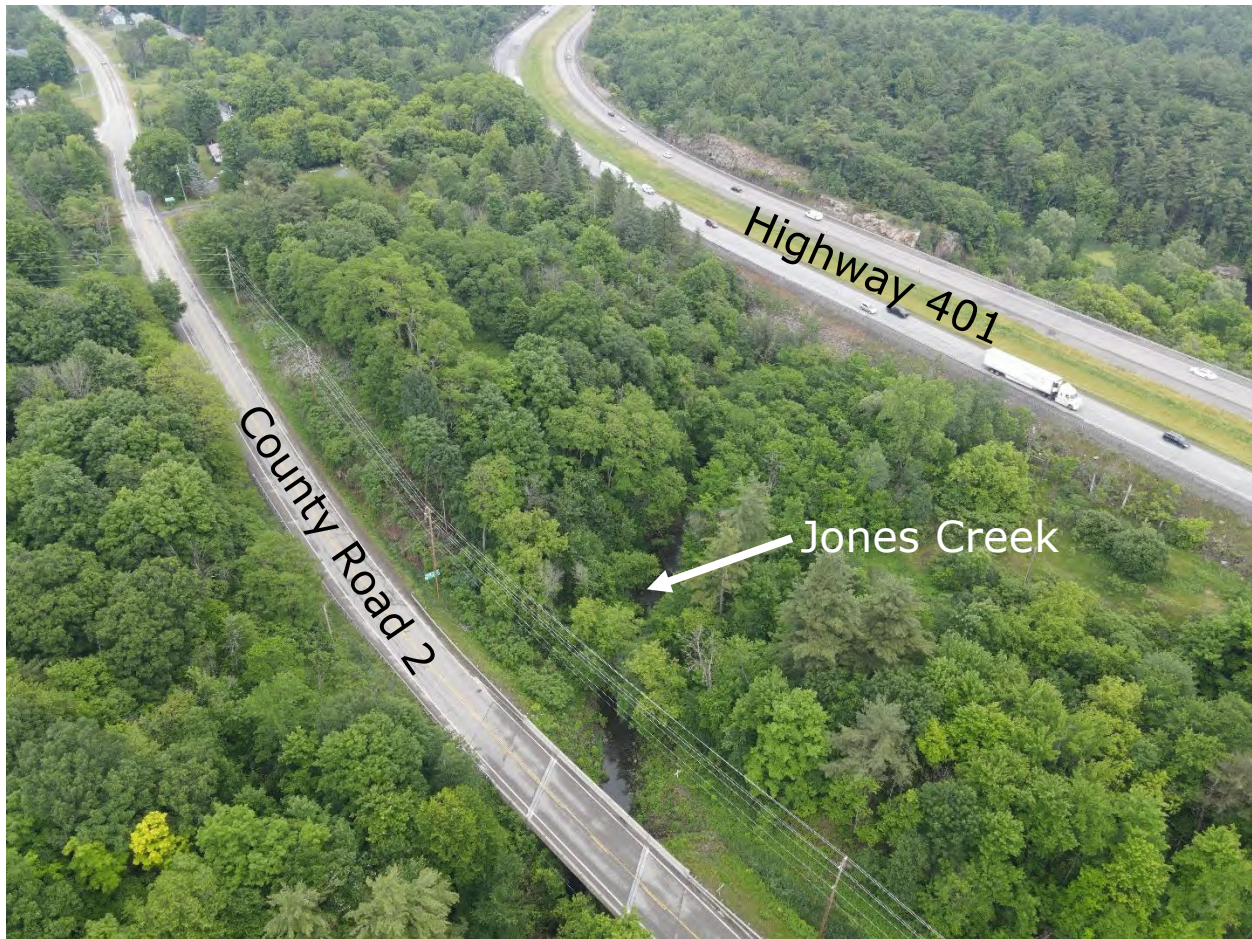
Figure 24: Aerial photo of the Jones Creek wildlife pathway where it is severed by County Road 2 and Highway 401 (© Thousand Islands National Park, 2023).

The easternmost pathway identified for mitigation efforts is the Jones Creek route (Figure 23). This area is arguably the most intact pathway of habitat moving north across the Frontenac Arch. Circuitscape analyses identified the Jones Creek pathway as a small pocket of high landscape connectivity between the Thousand Islands Parkway and Highway 401. It also has a high NHS score with great potential for habitat linkages on both sides of Highway 401. The large, provincially significant Jones Creek Marsh within this pathway connects with Charleston Lake Provincial Park through riparian and forested linkages. A meandering stream runs east from Charleston Lake Provincial Park passing by several small wetland complexes and eventually crosses under Highway 401 where it meets the St. Lawrence River at Jones Creek. This level of habitat connectivity is rare in southeastern Ontario and serves as a critical link in the Algonquin to Adirondacks connection.

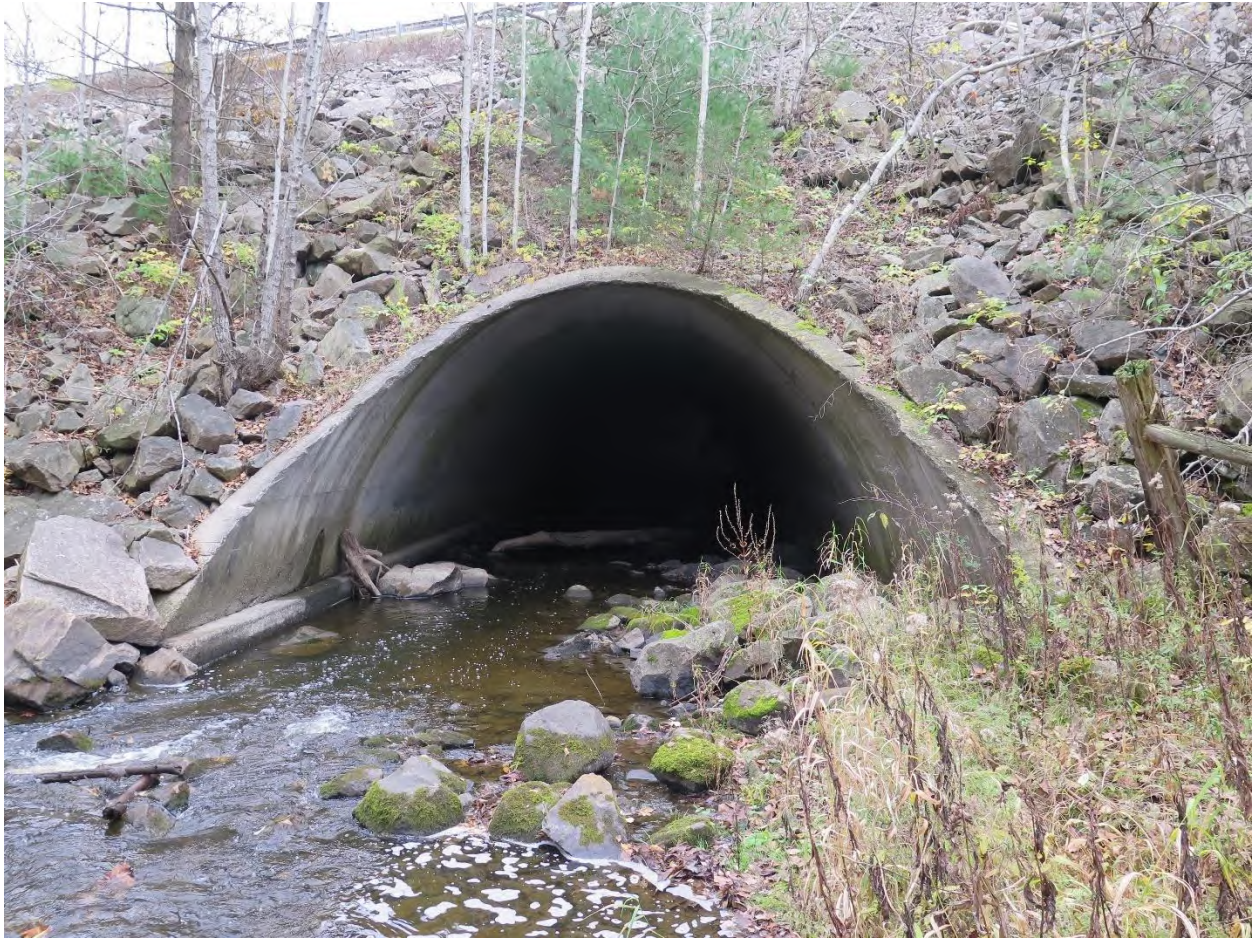
Figure 25: Photo of Jones Creek underpass at Highway 401.

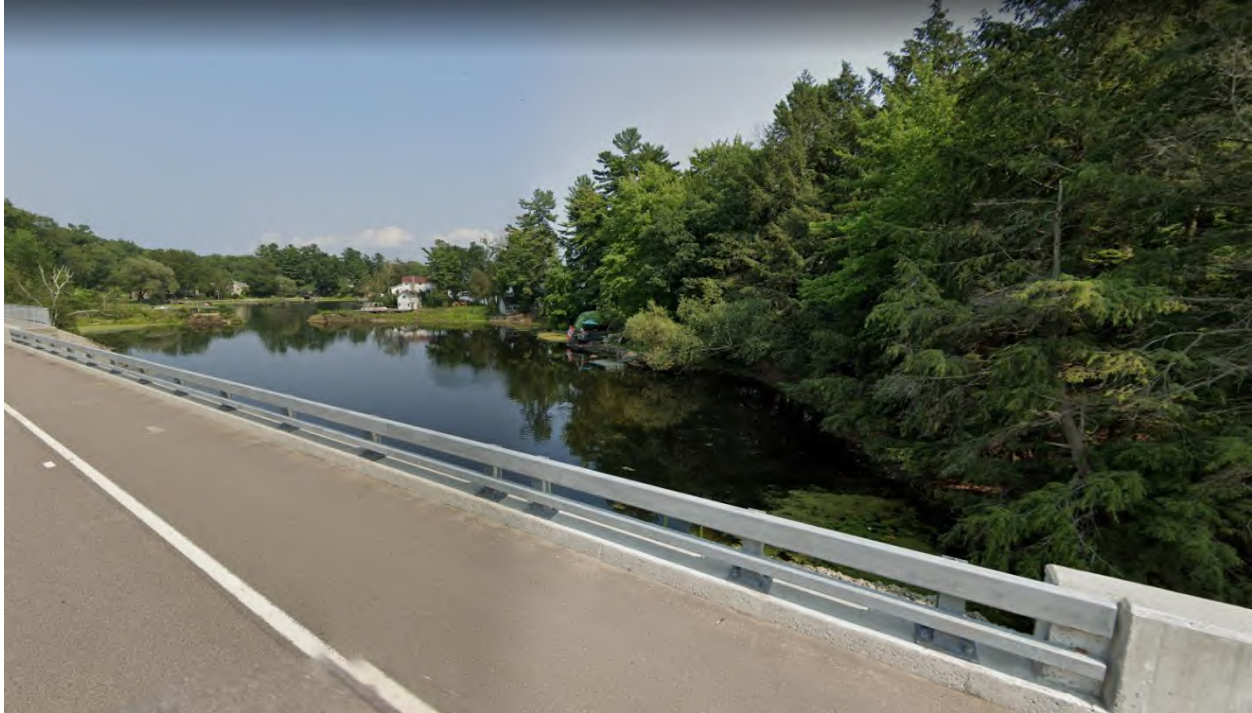
Figure 26: Photo of the Thousand Islands Parkway bridge at Jones Creek.

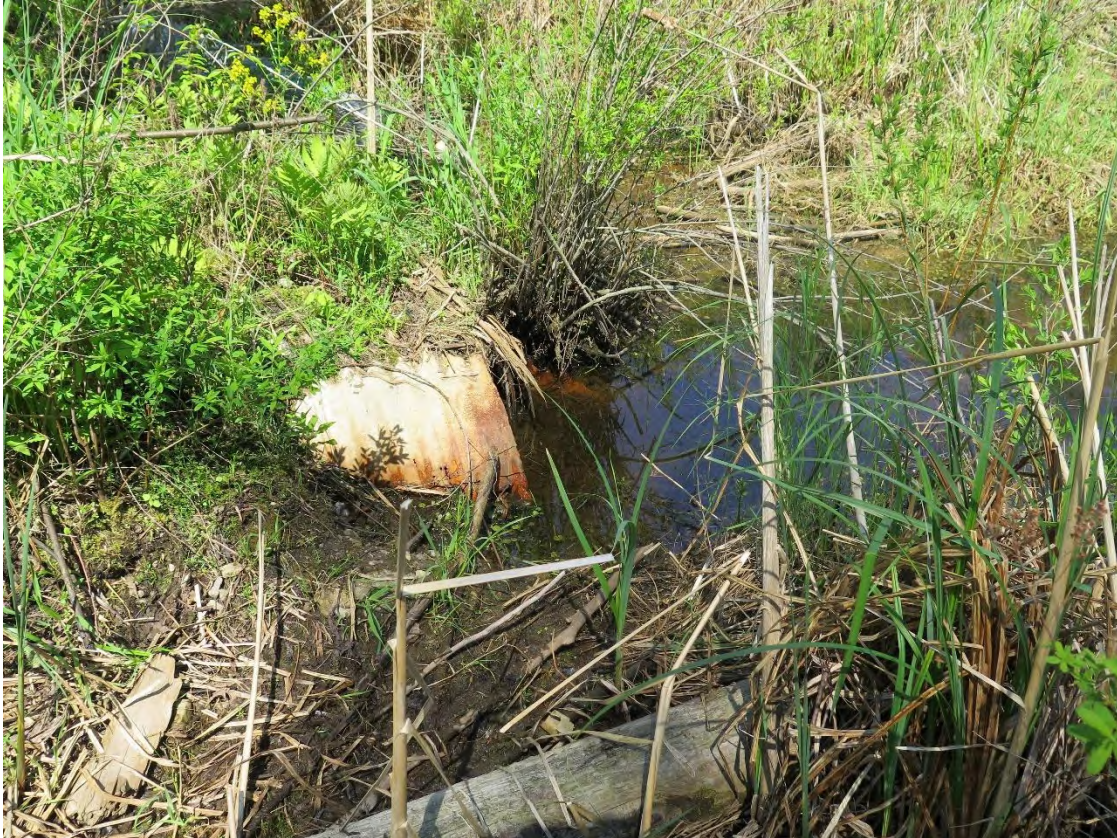
Figure 27: Photo of the undersized culvert on County Road 2 within the Jones Creek pathway.

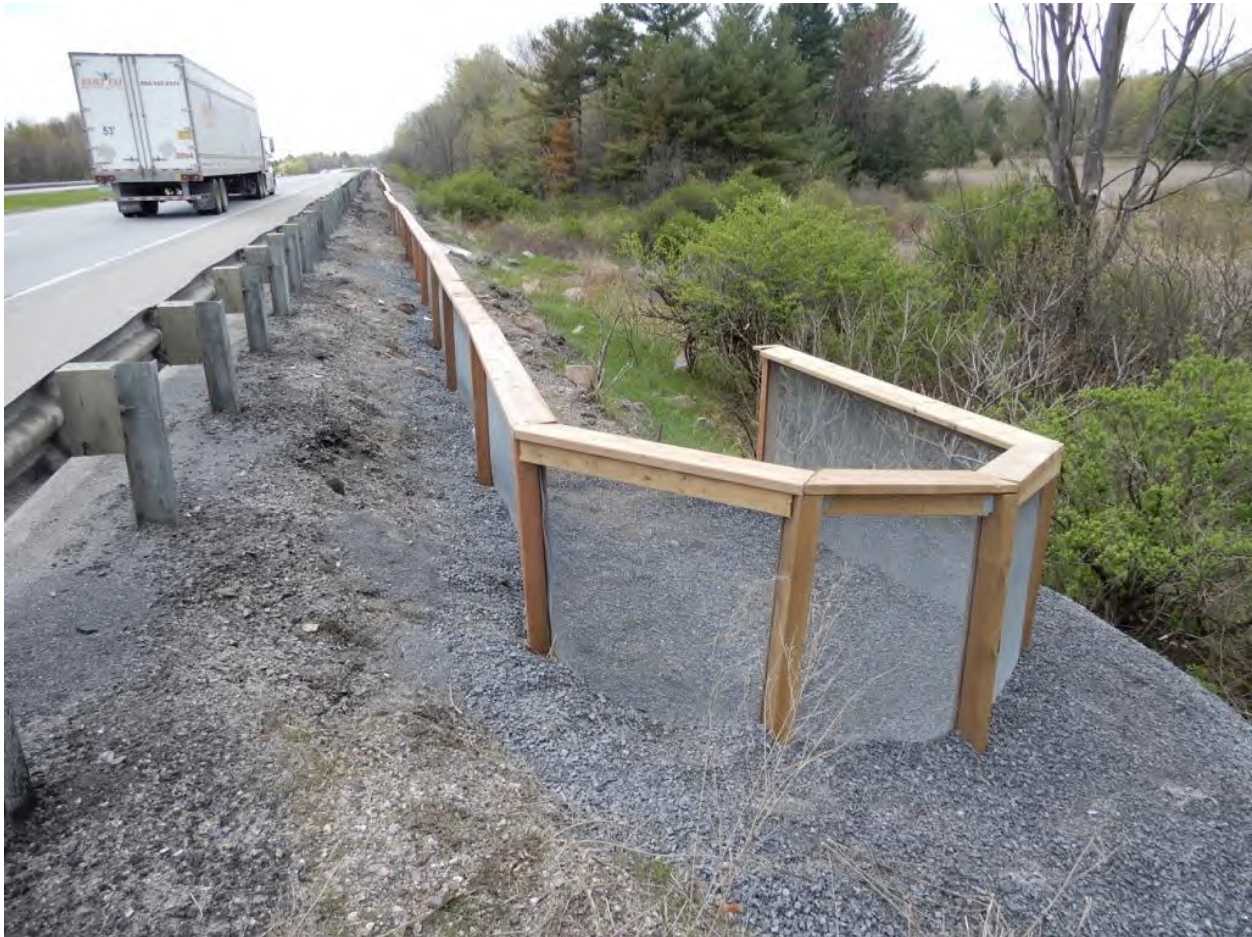
Figure B3: A section of fencing installed on Highway 401, intended to prevent entry of turtles onto the roadway and facilitate their use of existing drainage culverts for safe crossing. Photo by R. Danby.

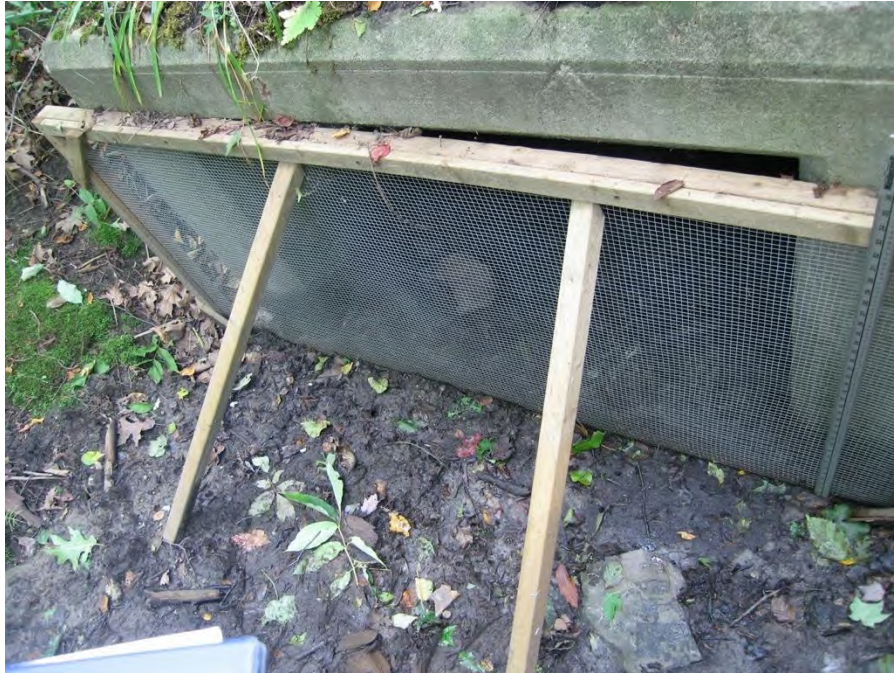
Figure B5: Grates were installed at six culverts along the Thousand Islands Parkway in 2009 and 2010 as part of a field experiment to evaluate the efficacy of culverts and roadside fencing in reducing vehicle-wildlife collisions. Results showed that culverts were effective for reducing road mortality but only when paired with fencing. Photo by R. Danby.

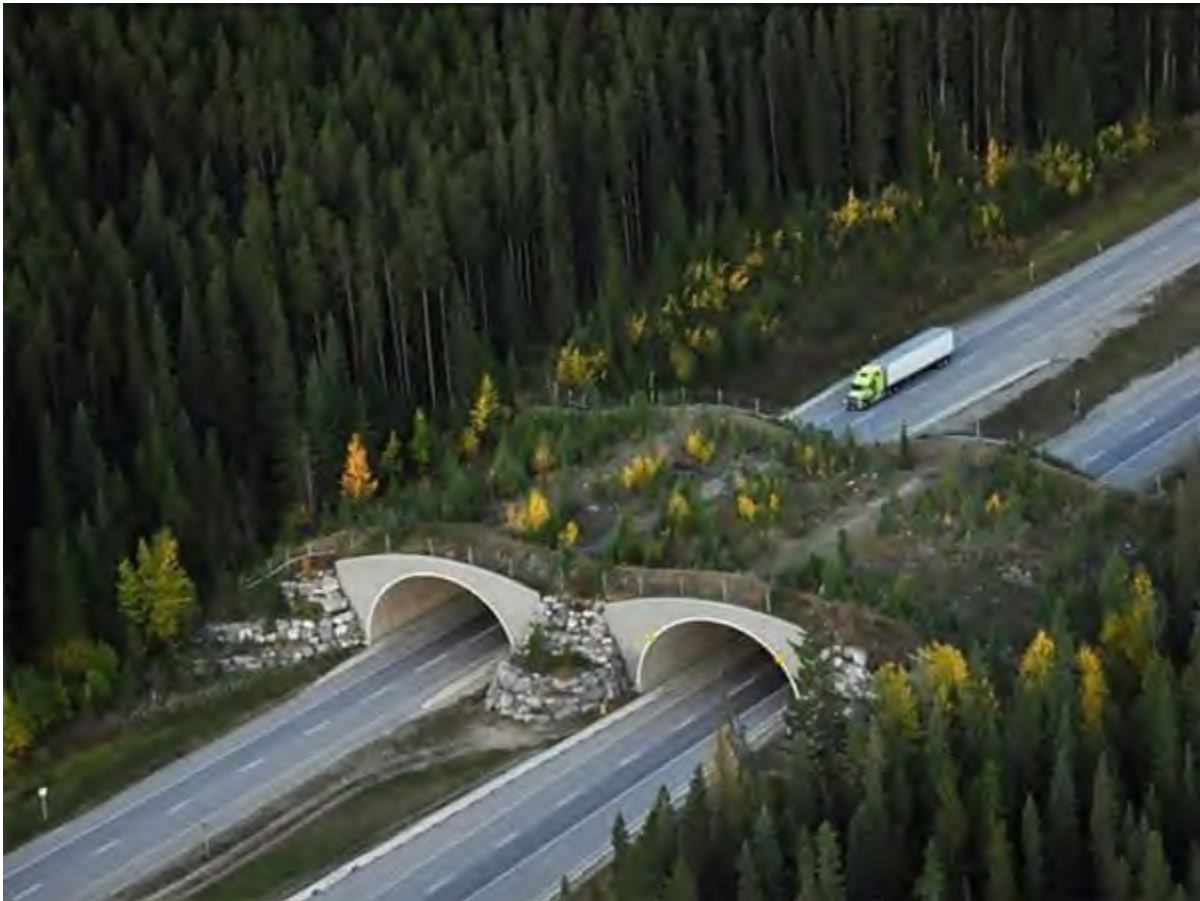
Figure D1: Wildlife overpass on the Trans-Canada Highway in Banff National Park.  
Image source: <https://9gag.com/gag/aE8L0ZG>

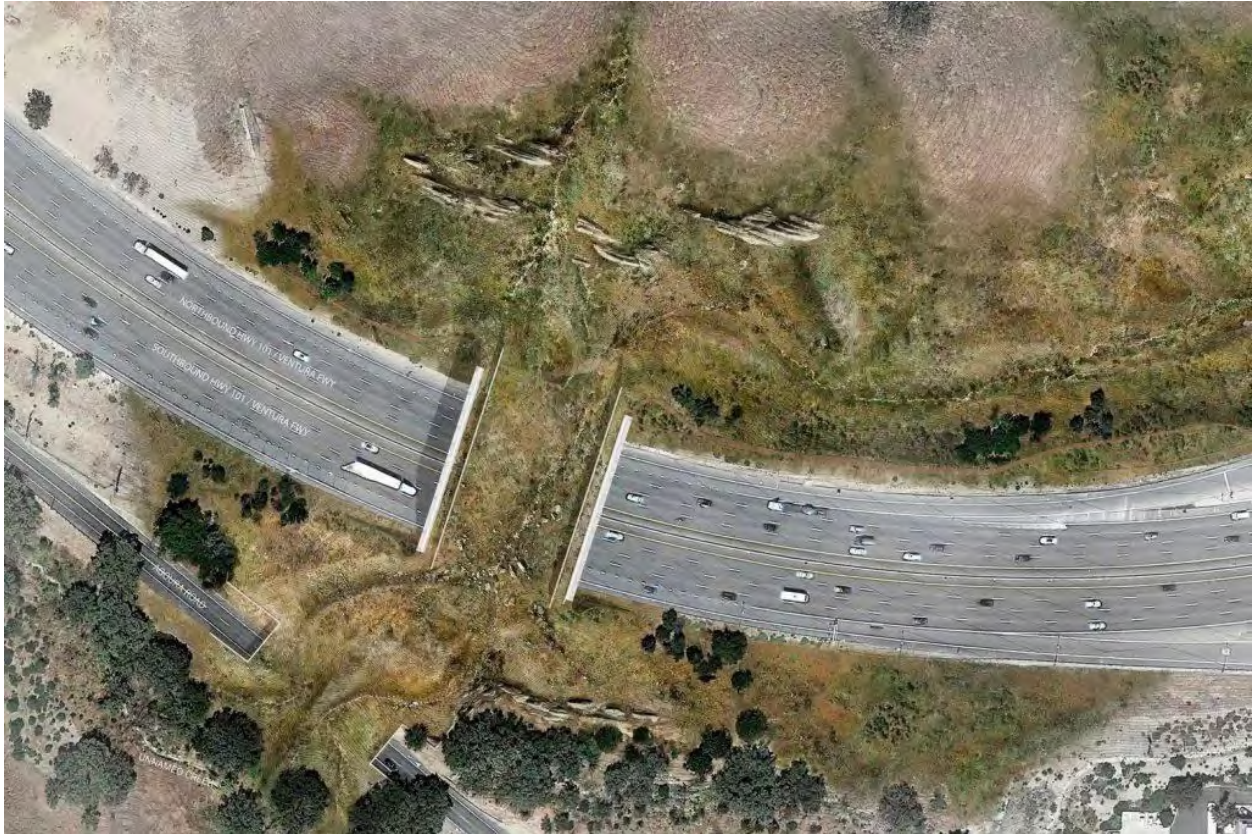
Figure D2: California's Wallis Annenberg Wildlife Crossing. Image source: <https://www.newcivilengineer.com/latest/worlds-largest-wildlife-crossing-breaks-ground-in-california-22-04-2022/>

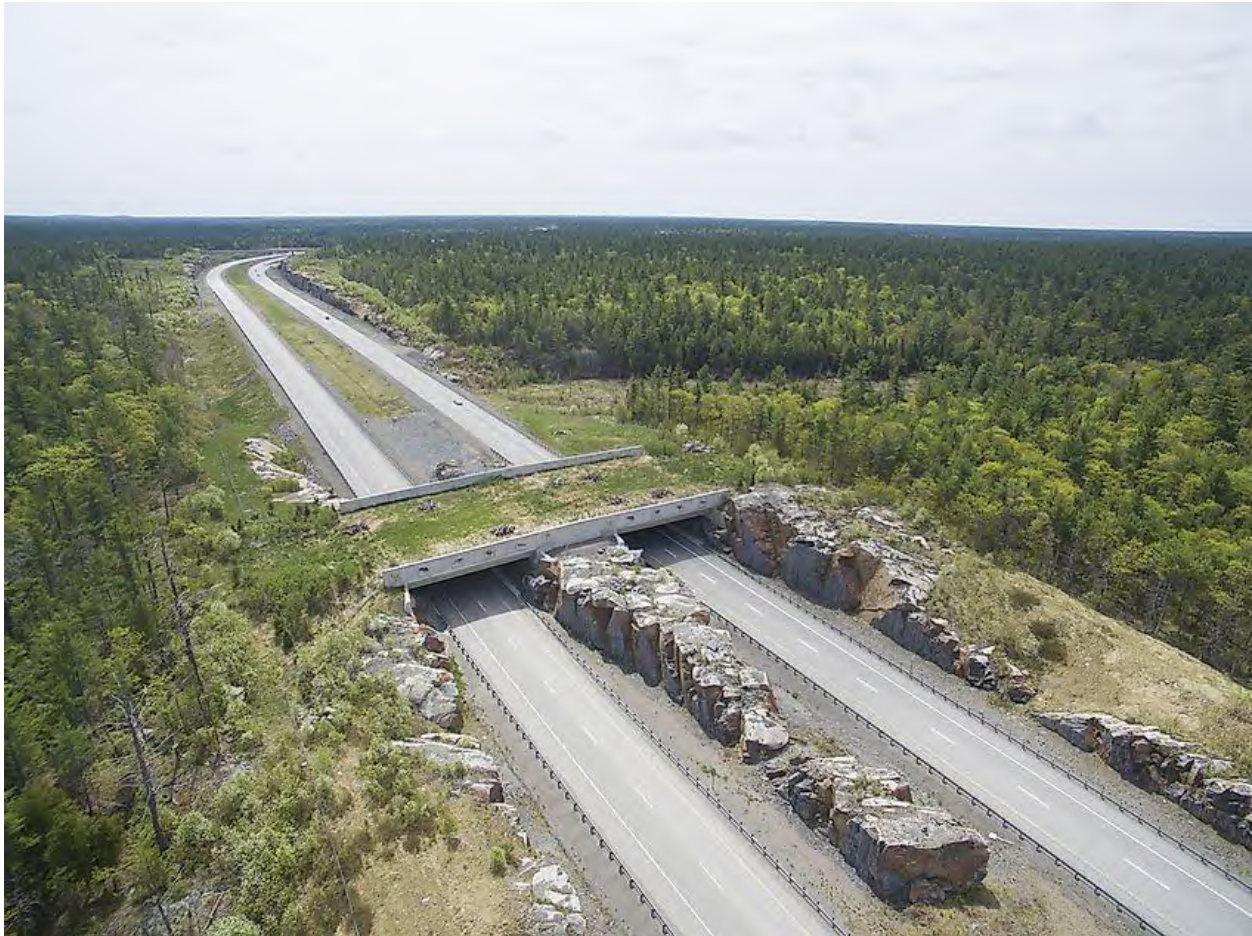
Figure D3: Wildlife overpass built on rock cuts. Image source:  
<https://www.worldatlas.com/articles/what-is-a-wildlife-pathway.html>

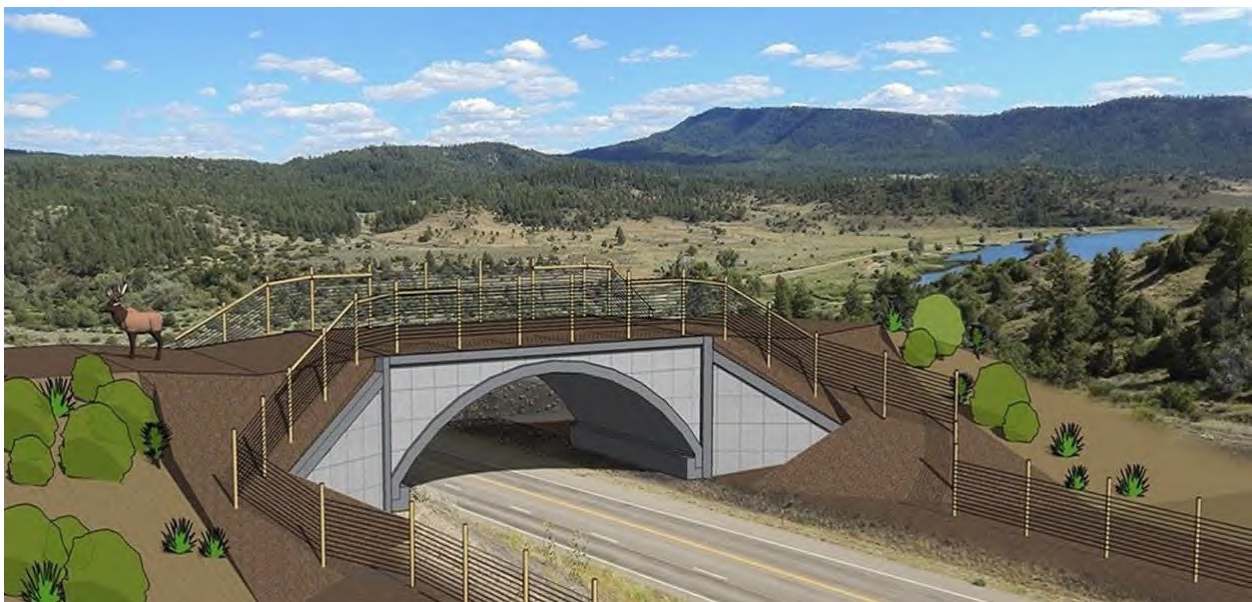
Figure D4: Example wildlife overpass design with fencing. Image source:  
<https://coloradooutdoorsmag.com/2020/12/09/colorado-wildlife-crossing/>

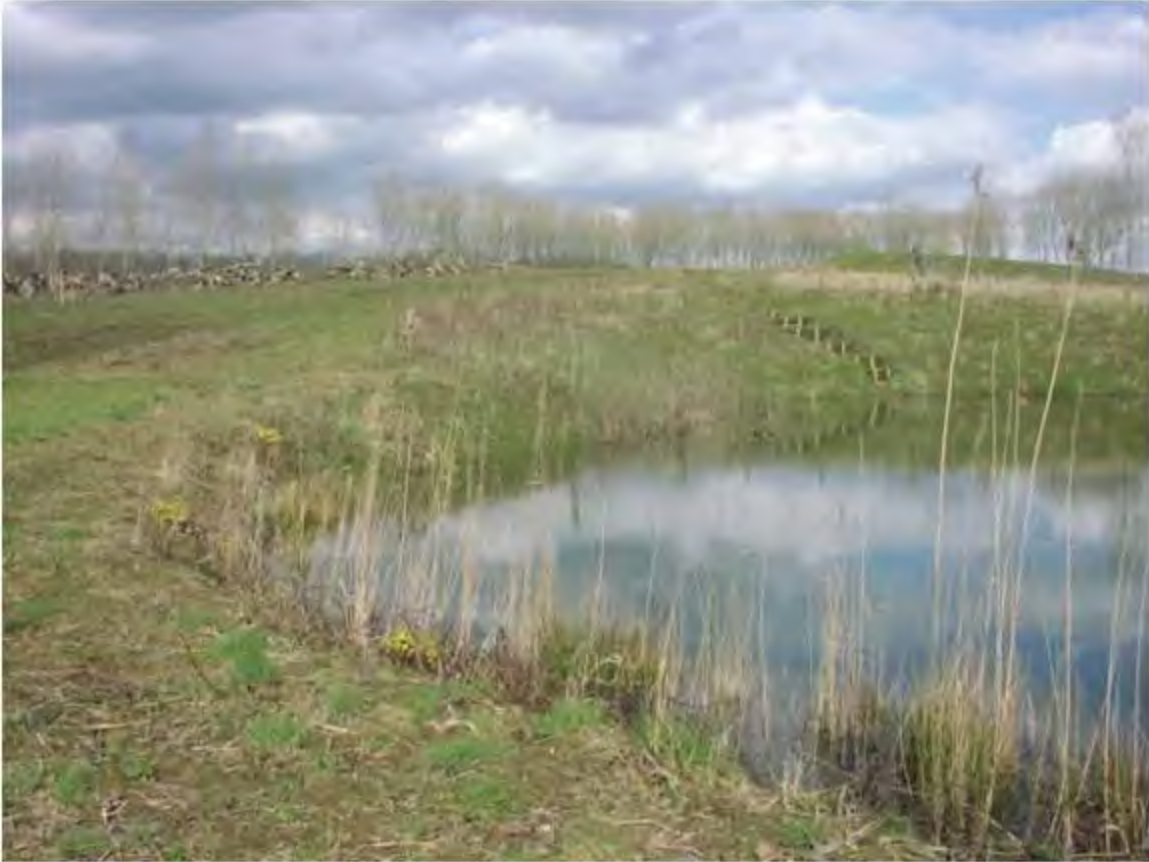
Figure D5: Constructed amphibian habitat at edge of wildlife overpass (© T. Clevenger via Clevenger & Huijser, 2011).

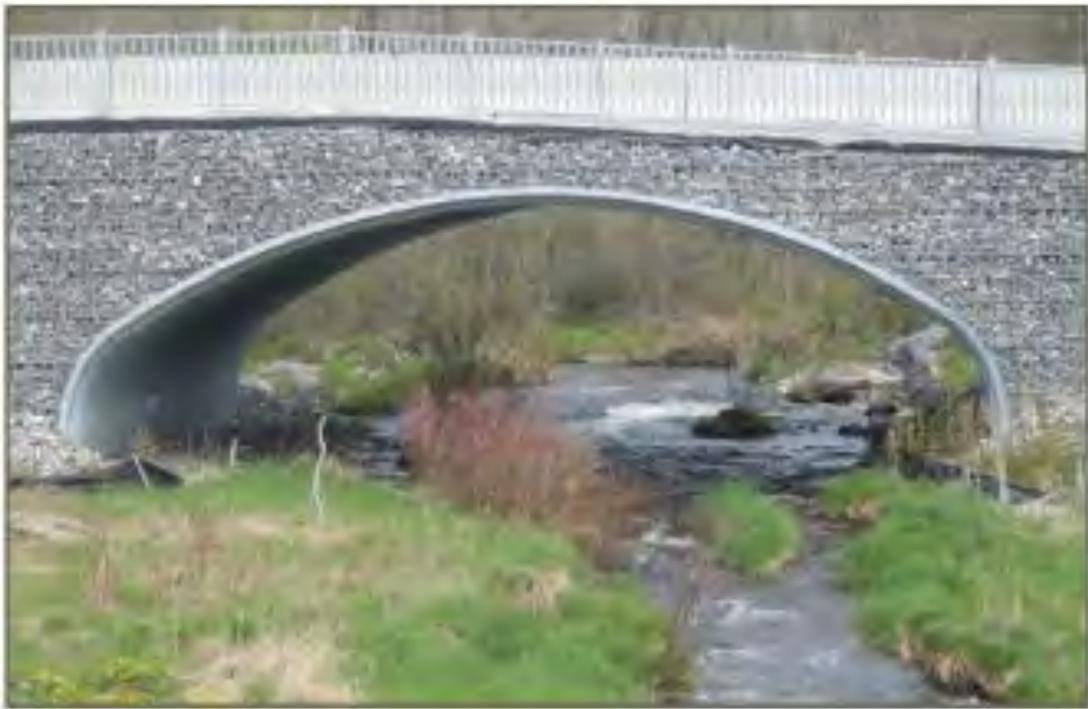
Figure E1: Wildlife underpass (arched tunnel) designed to incorporate a natural stream crossing and associated riparian area (© D. Seburn via OMNRF, 2016).

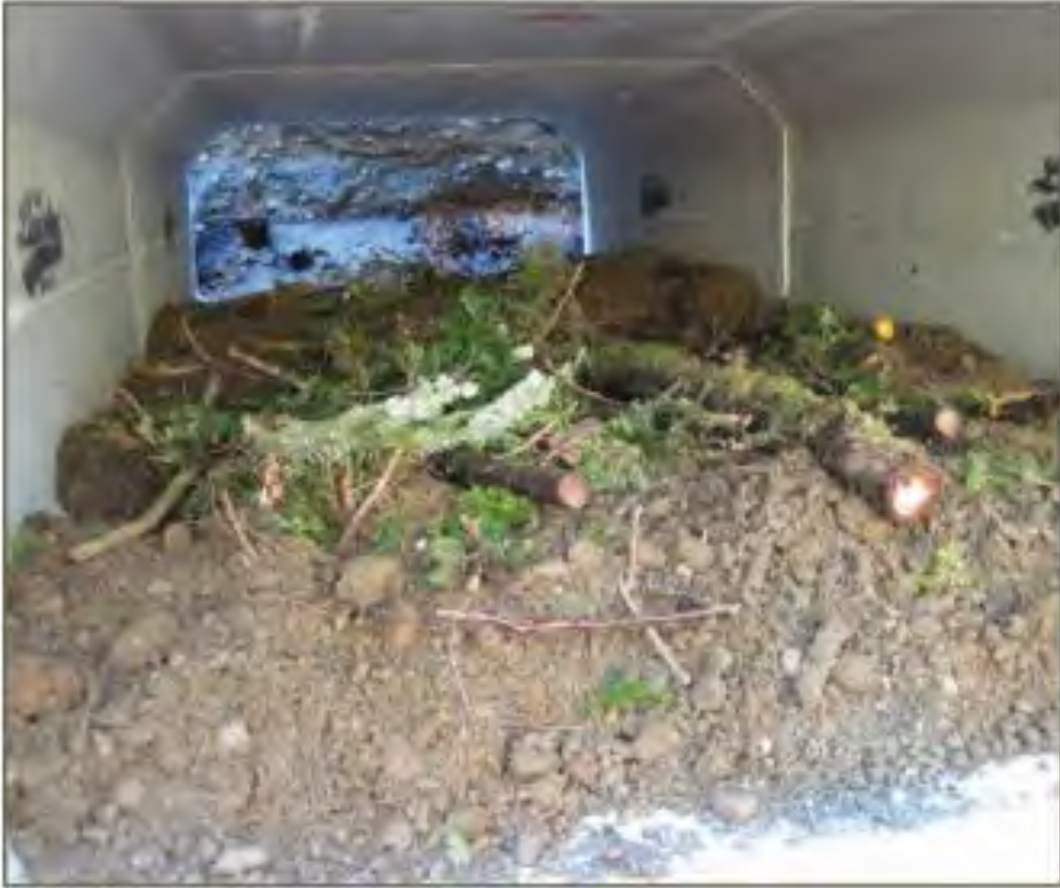
Figure E4: Wildlife underpass (box culvert) with soil and branches inside tunnel to increase microhabitat structure and complexity (© B. Beasley via OMNRF, 2016).
