# The Right to Roam: A Strategy to Reconnect a Continental Wildlife Pathway in the Frontenac Arch

June 19, 2023

This report was prepared by the following authors on behalf of the Algonquin to Adirondacks Collaborative (A2A):

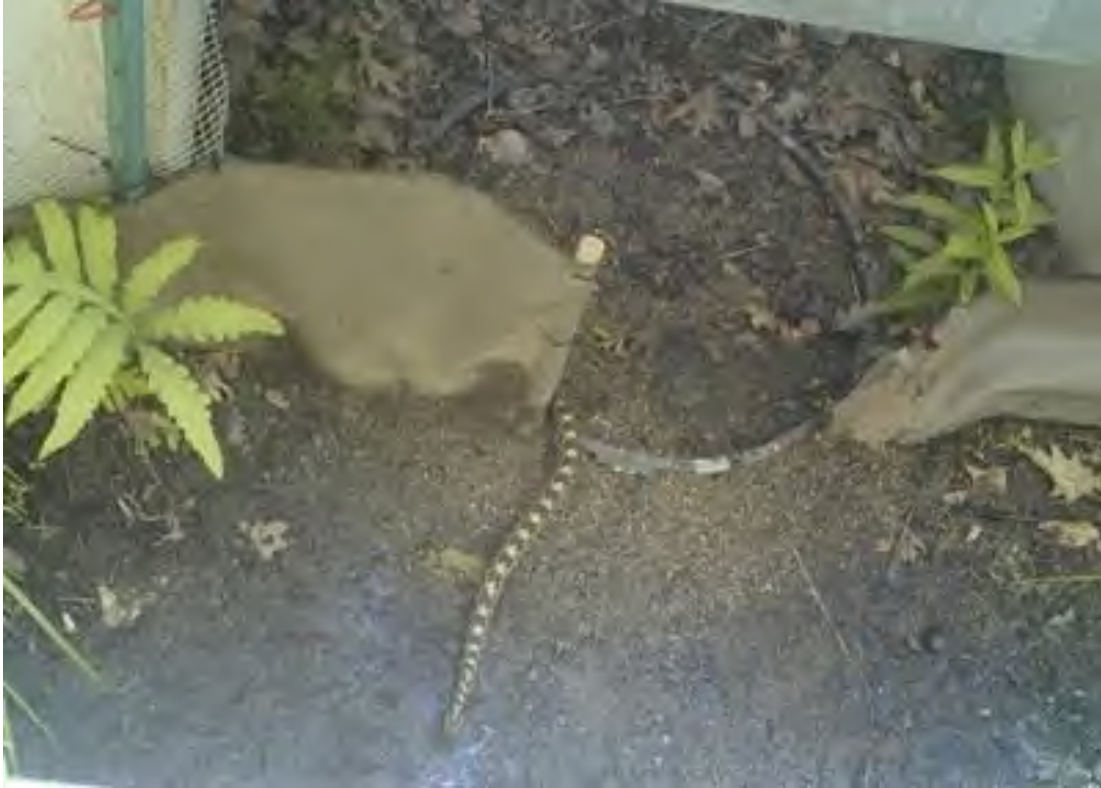
Figure E5: Massasauga rattlesnake exiting an underpass with natural substrate, vegetation cover, and wildlife fencing. Image source: <https://www.ontarioparks.com/parksblog/ecopassages-help-wildlife-cross-roads-safely/>

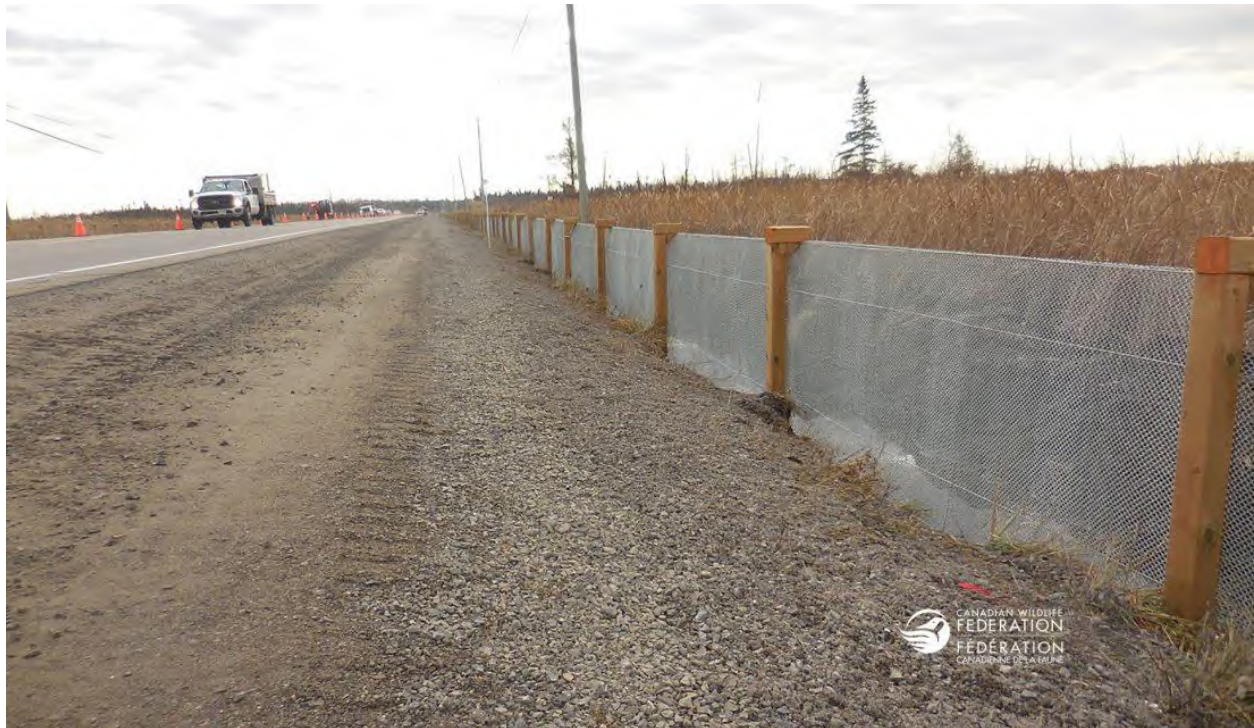
Figure F1: Roadside turtle fencing in Ottawa, made of hardwire mesh and wooden poles. Image source: <https://blog.cwf-fcf.org/index.php/en/victory-for-eastern-ontarios-freshwater-turtles/>

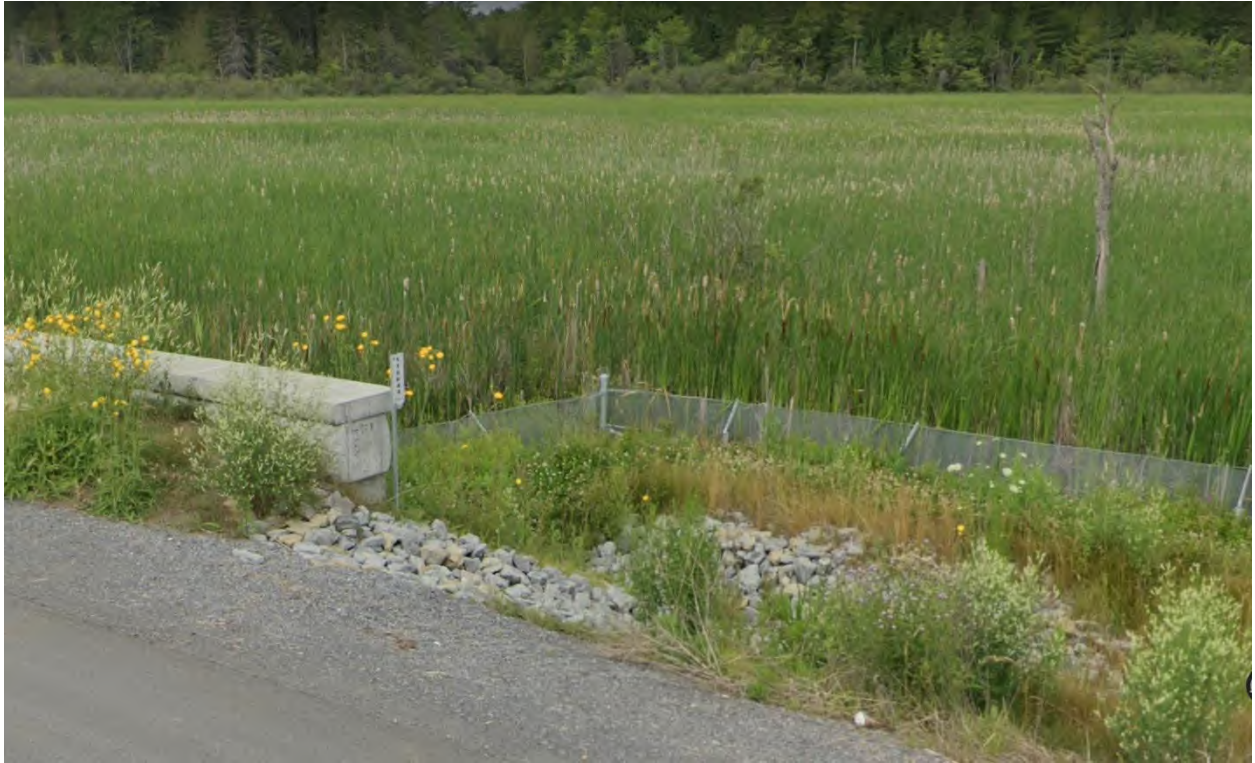
Figure F2: Two-metre-tall wildlife exclusion fence (hardwire mesh and metal poles) with overhang tied into concrete wildlife barrier along wetland habitat in Ottawa (© K. Black).

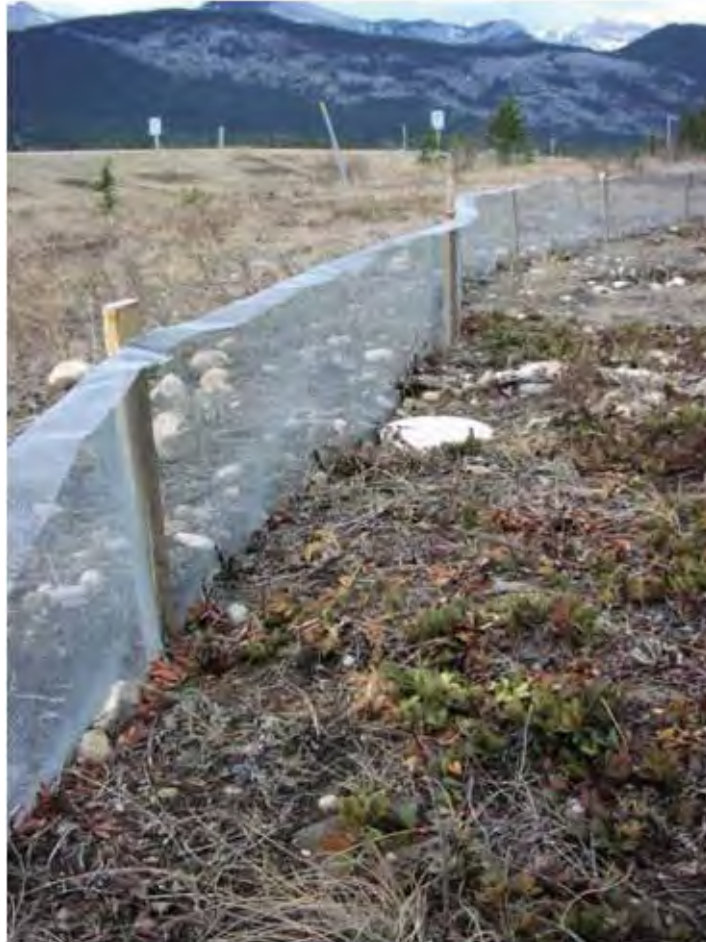
Figure F3: Reptile and amphibian fence with overhang, made of hardwire mesh and wooden stakes (© T. Clevenger via Clevenger & Huijser, 2011).

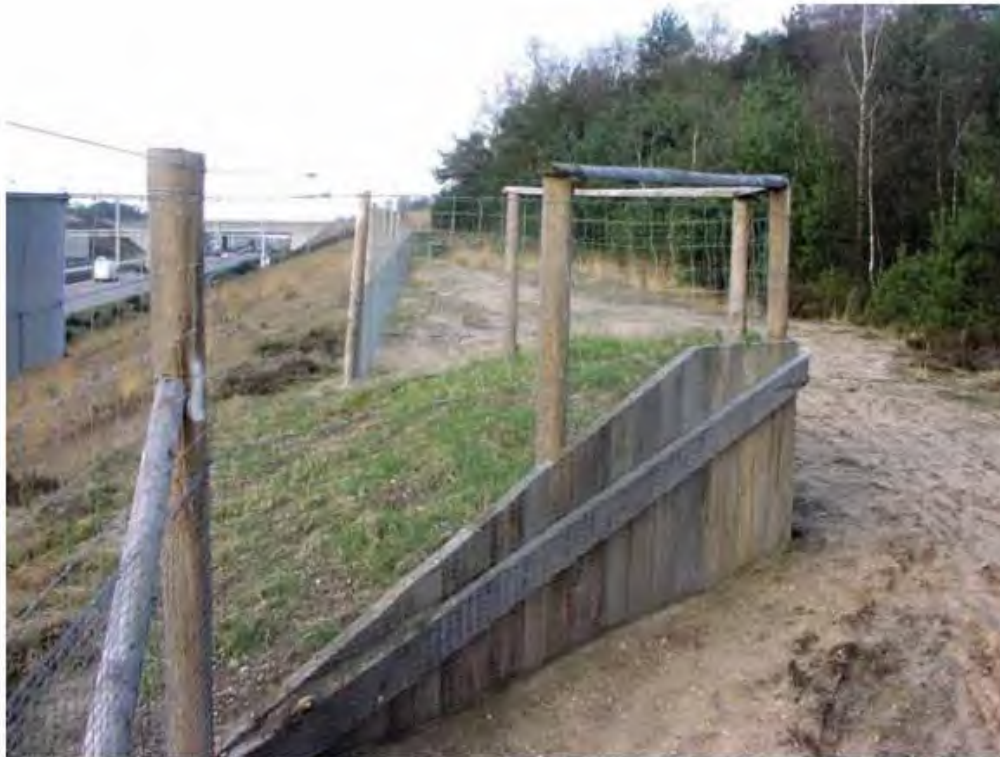
Figure F4: Large mammal exclusion fence made of metal wire and wooden poles (© T. Clevenger via Clevenger & Huijser, 2011). This photo shows an escape ramp (jump-out) for wildlife that get trapped inside the right-of-way. Note that this gauge of wire is not effective for excluding small animals, and metal posts are recommended over wood.
